# **Kutzky Park and Slatterly Park Neighborhoods Pilot Infiltration/Inflow (I/I) Study City Council Update**

City of Rochester, MN  
May 23, 2011

- Present findings, conclusions and recommendations of the Pilot Infiltration/Inflow (I/I) Investigation Study
  - Results of sanitary sewer system analysis
    - Sources of infiltration and inflow (I/I) – private and public sectors
    - Maintenance and structural evaluation
    - Hydraulic evaluation
    - Causes of sewer backups
  - Recommendations

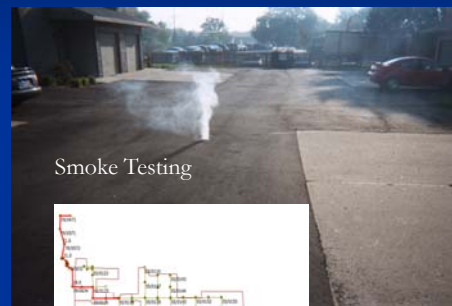
Smoke Testing

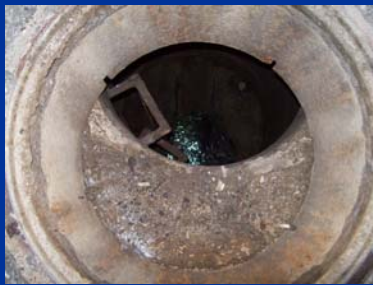
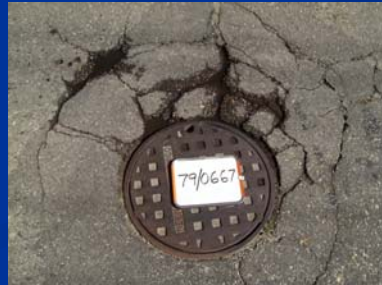
## Key Manhole Findings

- I/I defects were common in the upper part of the manhole
  - Cover, frame seal, chimney
- Confirmed/updated system configuration
  - Location, depth, pipe size

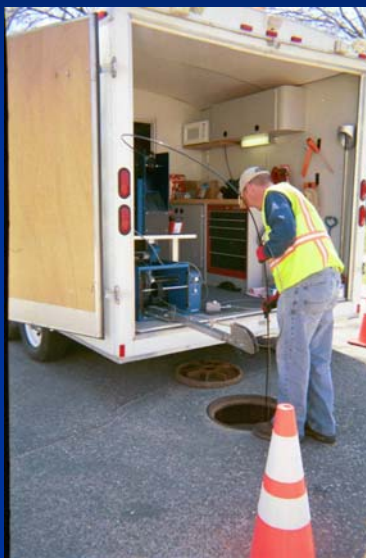
## CCTV: Documenting and Assessing Public Sewer Main Condition

- Defect Types
  - Crack/Fracture
  - Roots
  - Joint Offset
  - Missing Mortar/Brick
  - Broken/Hole
  - Collapsed
  - Tap Defective/Intruding

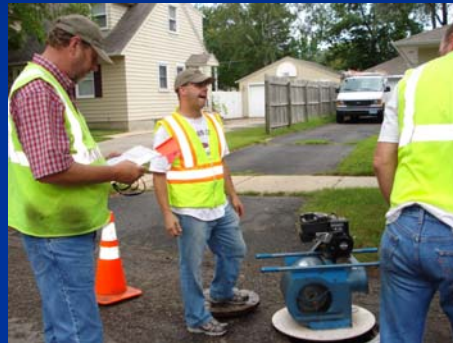
## Smoke Testing Was Used to Find Direct and Indirect Sources of I/I

- Notification Process
  - Property owners and Fire Department
- Located direct and indirect connections to the sanitary sewer system

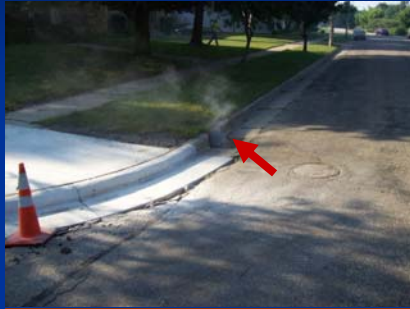
Inlet Inflow - 7<sup>th</sup> and 10<sup>th</sup> Ave SE

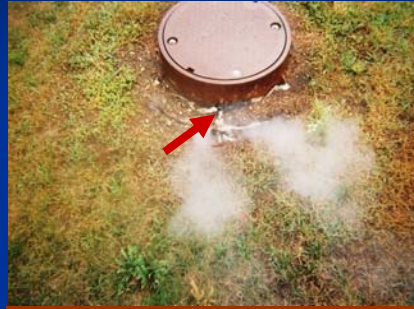
Manhole Inflow

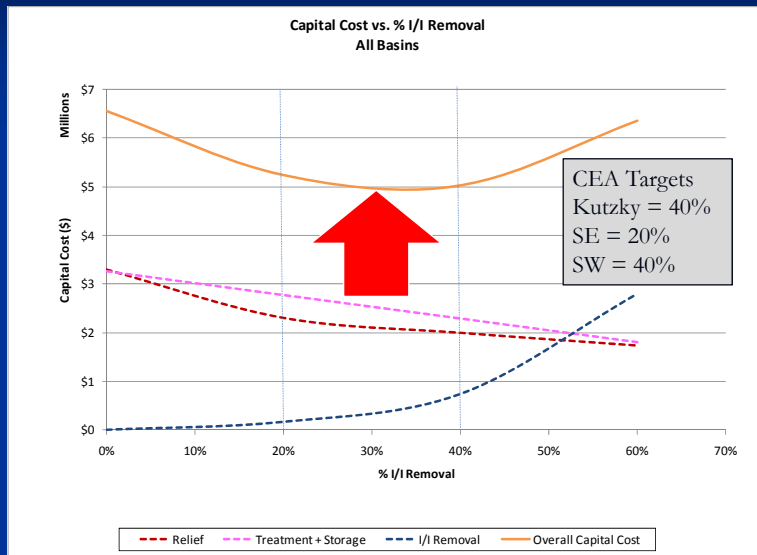
## Cost-Effectiveness Analyses Identified Target I/I Removal and Basis for Relief Sizing

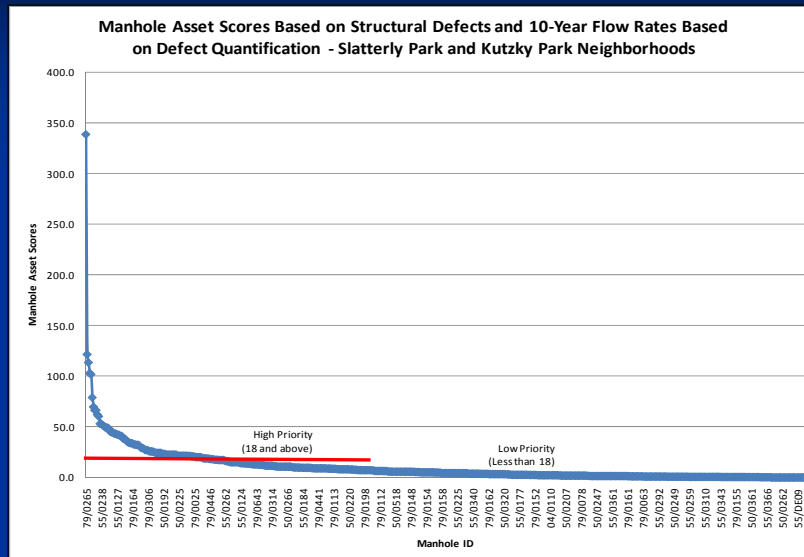
## Manhole Ratings Identified 100 Manholes to Rehabilitate

## Manhole Rehabilitation Plan – Completed in 2010

Sewershed	Number of Manholes	10 Year Flow Rate Reduction (gpm)	Capital Cost*
Kutzky Park	38	148.7	\$ 79,000
Slatterly Park East	22	81.2	\$45,000
Slatterly Park West	40	161.6	\$84,000
<b>Total</b>	<b>100</b>	<b>391.5</b>	<b>\$ 208,000</b>
